Mifflinburg Log House Restoration, A labor of love

By Carol Bohn

ACCOUNTS Vol. 4, No. 2, 2014 Union County Historical Society

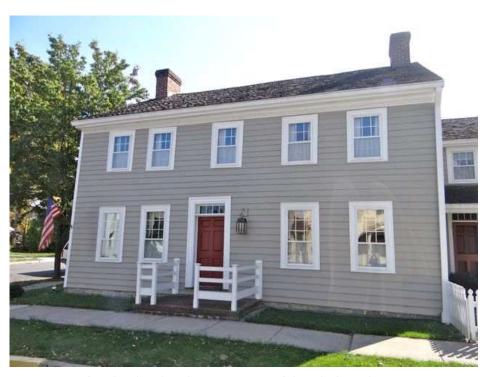
Front façade, showing the asymmetry of the window placement

An unusual aspect of the house is the asymmetric placement of the front door. A common feature in this type of log structure is the alignment of the front door with the back door. However, in *this* house the front door is not centered in the façade. Why? There is no known explanation. In keeping with the Georgian/Federal style, the window placement in the front of this house has two windows on each side of the door on ground level, and windows on the second floor align with the ground floor windows on each side, but the center window does not align with the offset front door.

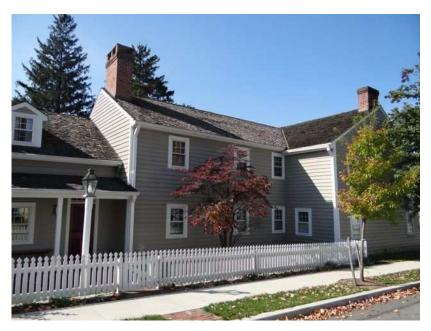
View from the side. The center and left-hand structures are later additions to the original structure.

Additions were added to the north and west sides of the house. These additions were carefully designed to replicate the original structure keeping the wall thickness and the size of windows the same. Most of the plumbing was kept in the new additions and low voltage electricity was installed behind

the moldings of the doorways. This was done because modern electrical boxes could not be put in beaded board walls measuring only 1 1/4" thick.

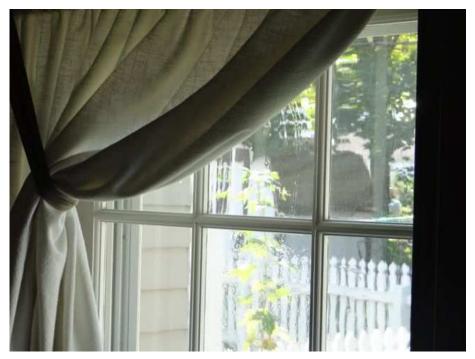
"Wavey" glass in downstairs windows.

Six over six window panes are found in the window frames throughout the house, except for the front windows on the ground floor which are 12 panes over 6. These windows may have been elongated at a later date. All window panes throughout the house, including the additions, are old wavy glass taken out of frames of early houses and farm outbuildings. I became an expert at replacing windows in old chicken coops!

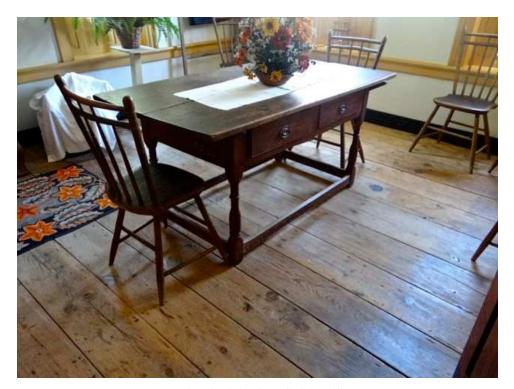
Example of original, unfinished floors

The floors are all unfinished---no stain, no polyurethane---simply a natural patina (a gloss or sheen on wood produced by age and polishing). Most of the original flooring was yellow pine and replacement was very costly and hard to find. Consequently, the flooring in the additions is white pine and poplar which was easier to obtain and less costly. This flooring, which was removed from old houses, was re-planed to a standard thickness and the tongue and groove feature was cut off. If the replacement boards had originally been painted, the paint was removed after they were re-laid, a laborious, time-consuming task. Although tongue and groove flooring was the original mode of construction, modern costs prohibited this type of

replication and the floors in the additions were butted together. And, no, we don't get splinters when walking barefoot....it is as though these old boards had passed through a planner many times.

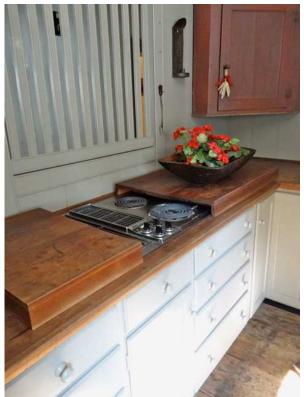
Contemporary kitchen appliances are hidden by sliding covers

The kitchen in the new section resembles an old tavern with large slated panels that can be raised or lowered to produce the tavern effect. The counter tops are old walnut boards sealed with olive oil and showing the patina of years of use. All modern appliances are disguised. The dishwasher, trash compactor, and refrigerator are covered with wood to match the painted cabinets. There are no cabinets above the counter tops but rather shelves to

display redware, tin and pottery. The cabinetry below the counter top consists of many storage drawers rather than the conventional door and shelving. A curtain on an iron rod swings away to reveal the oven; another

swings away to access the microwave. A 2" raised walnut box slides apart to reveal the Jenn-air grill and stove top. A large walk-in pantry with an upright freezer is adjacent to the kitchen area. The keeping room with a walk-in fireplace and bake oven adjoins one side of the kitchen.

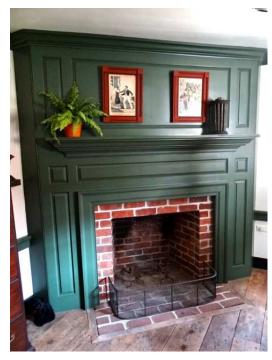
A new corner fireplace replaces an absent original

The Bohn home today has 5200 livable square feet. The original log part has a formal living room with a corner fireplace that abuts to a corresponding corner fireplace in the library. This was an instance where the house spoke to me. Both fireplaces were gone and only when removing the wallboard, which covered beaded board walls and ceiling, did I discover

indications of corner fireplaces (there were no beaded boards, simply gaps which had been covered with wallboard). An exciting discovery! The remaining rooms in the log structure include a formal dining room, country pantry, and a small powder room under the stairway.

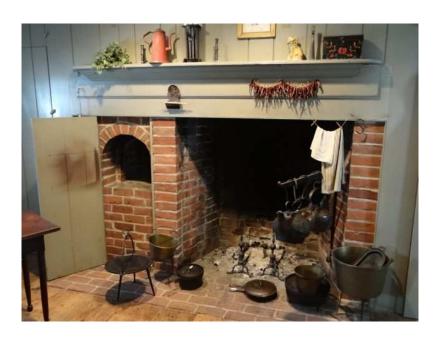
Cooking fireplace and bread oven in the keeping room
